**PERFORMANCE-BASED BID SPECIFICATIONS FOR THE
REMEDiation OF THE
FORMER TUBERCULOSIS HOSPITAL
2001 GARDEN BOULEVARD
LIMA, OHIO 45805**

**ALLEN COUNTY LAND BANK, AS FUNDED THROUGH THE
OHIO DEPARTMENT OF DEVELOPMENT BROWNFIELD
REMEDiation FUND PROGRAM**

**CIVIL & ENVIRONMENTAL CONSULTANTS, INC.
TOLEDO, OHIO 43604**

CEC PROJECT 341-509

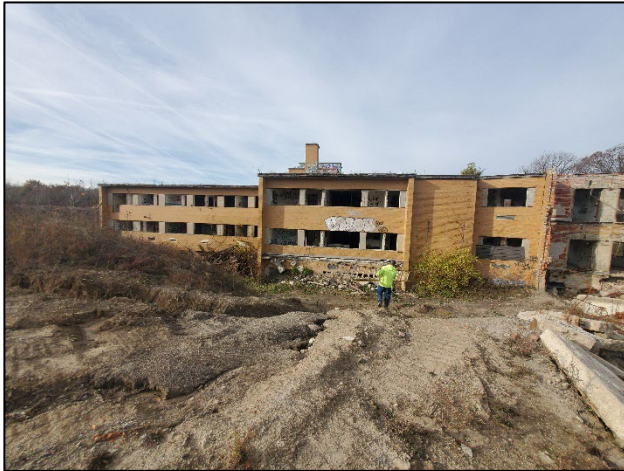
Photo 1: East Former TB Hospital building façade.

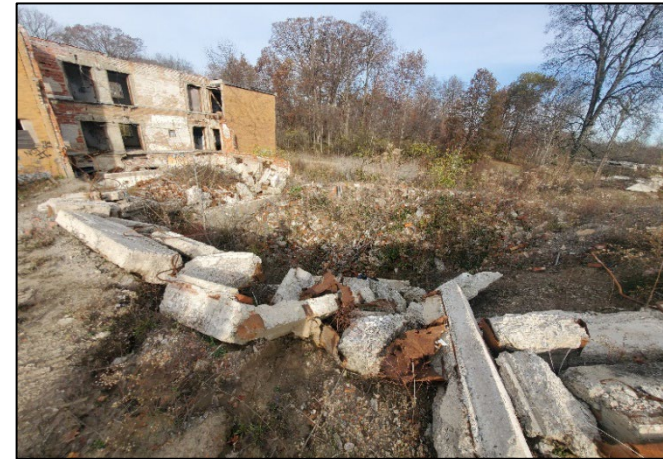
Photo 2: East Former TB Hospital building façade and construction debris.

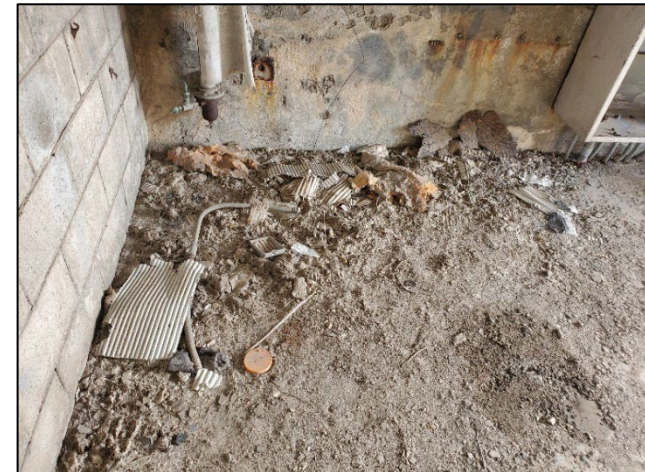
Photo 4: View of asbestos-contaminated debris (typ.).

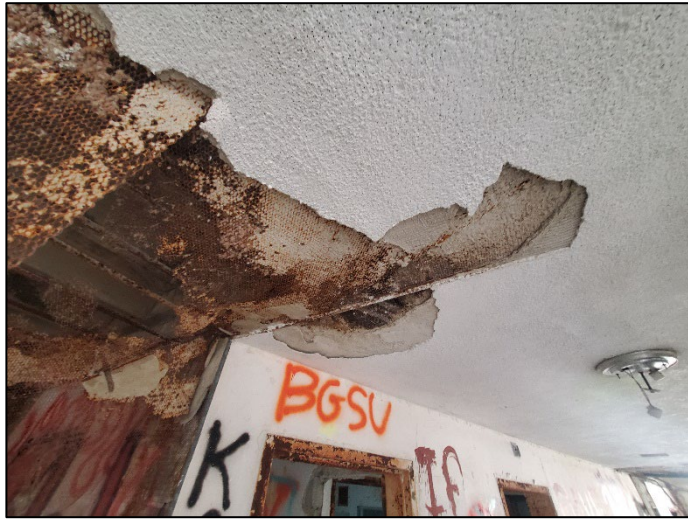
Photo 5: View of acoustical surfacing material.

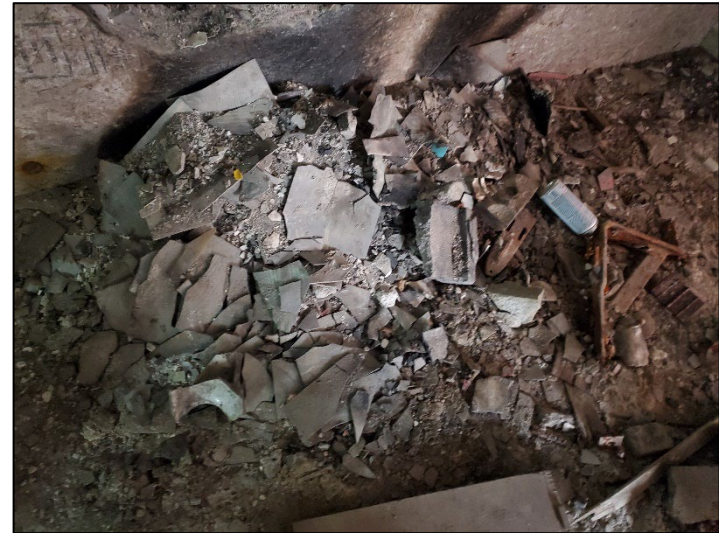
Photo 6: View of asbestos contaminated debris (typ.).

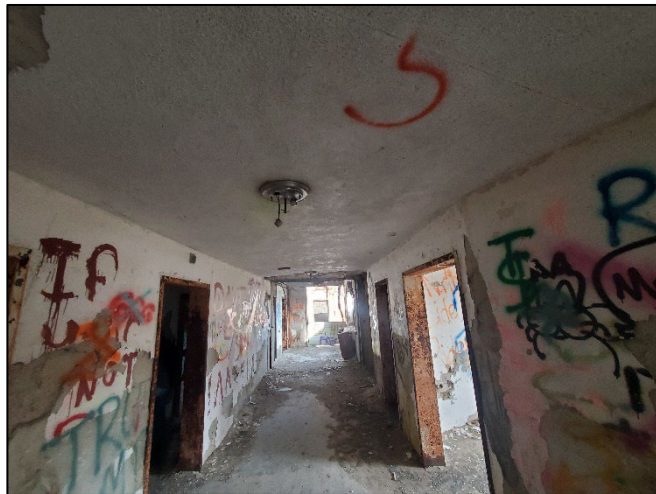
Photo 7: View of acoustical surfacing material.

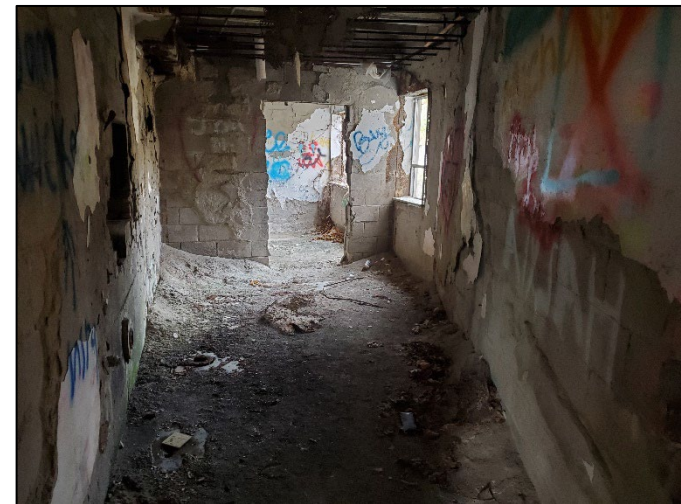
Photo 8: View of asbestos contaminated debris (typ.).

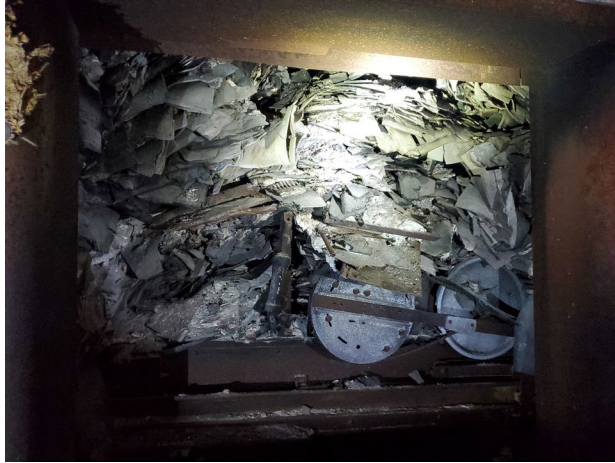
Photo 9: View of asbestos contaminated debris in the elevator shaft.

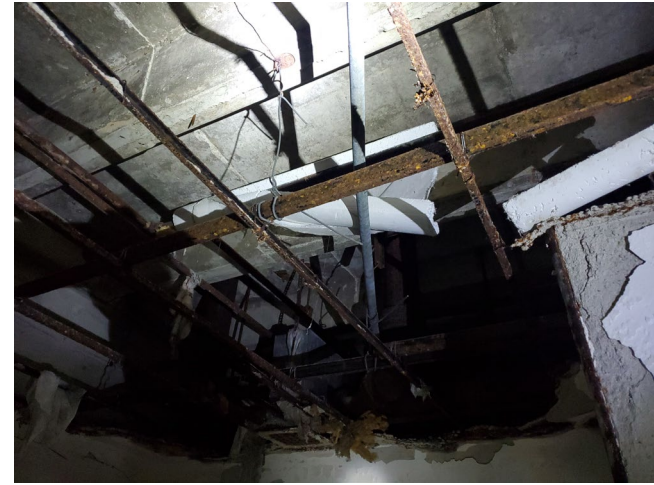
Photo 10: Mag insulation on pipe runs.

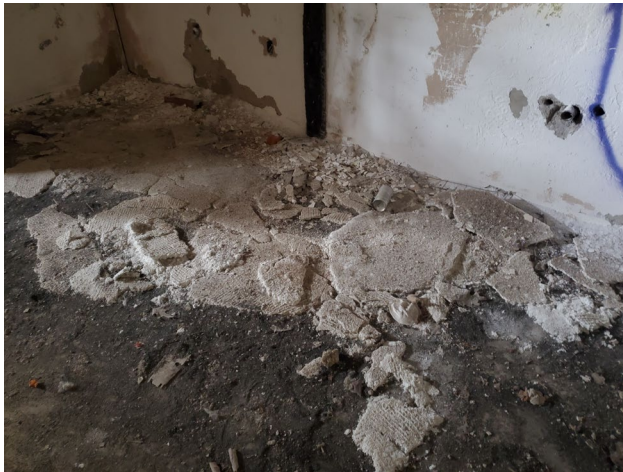
Photo 11: View of asbestos contaminated debris (typ.).

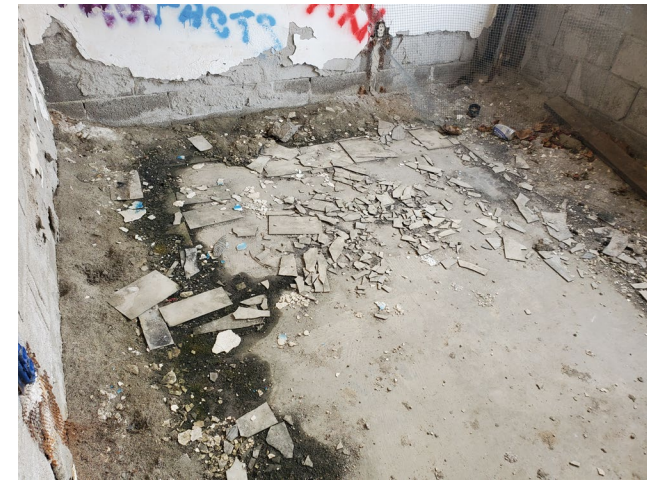
Photo 12: View of friable vinyl floor tile.
